BioWorld Products

Bunker "C" Fuel Oil Bioremediation Case Study

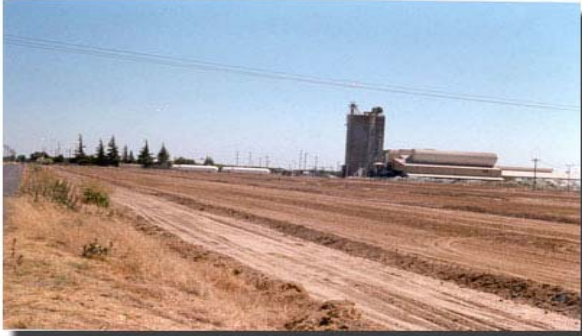
Old wooden fuel storage tanks were excavated and 6,000 cubic yards of contaminated soil was spread over a 4 acre area in 12 parcels – 1 foot deep

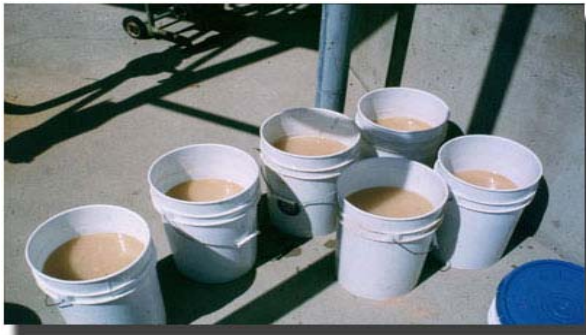
BioWorld Hydrocarbon Degrading Microbes were activated in warm water prior to application – then added to a water truck.

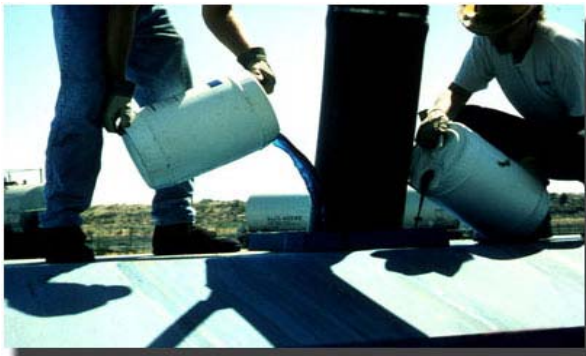
Technicians added BioWorld Bioremediation Enhancer to a 4,000 gallon water truck.

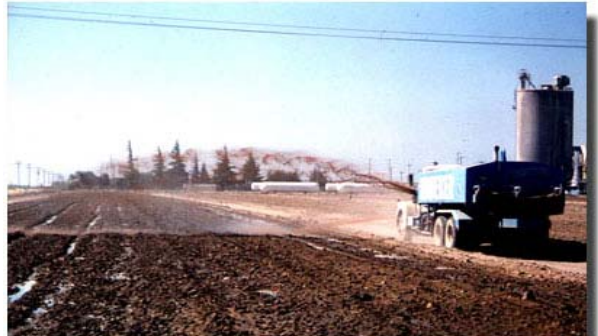
Water and BioWorld Bioremediation Technology products were applied to the contaminated soil using the water truck.

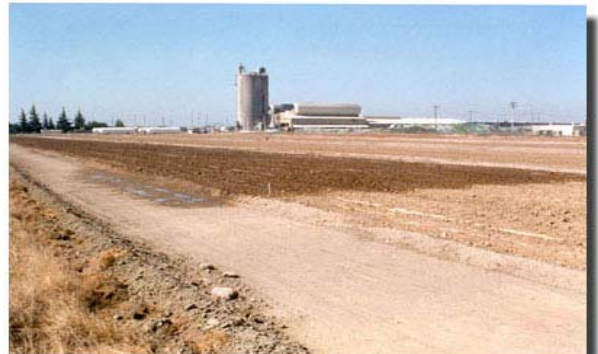
Each of the 12 separate parcels was treated on a monthly basis.

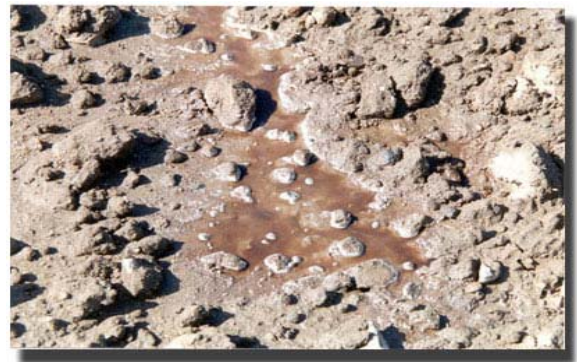
Close-up of the soil shows water and BioWorld Hydrocarbon Treatment product absorption.

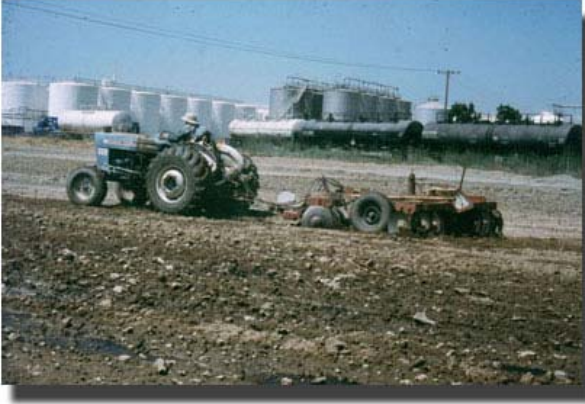
The soil was disced for mixing and aeration on a regular basis.

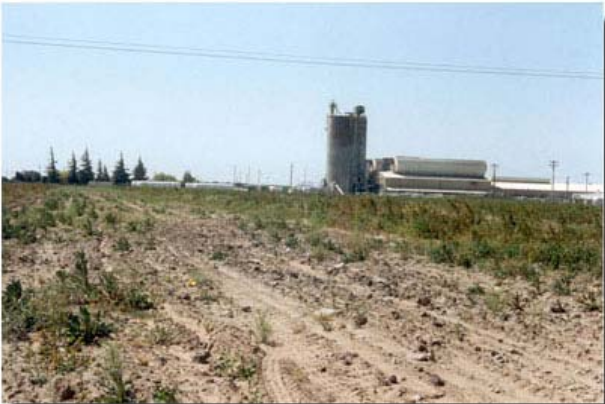
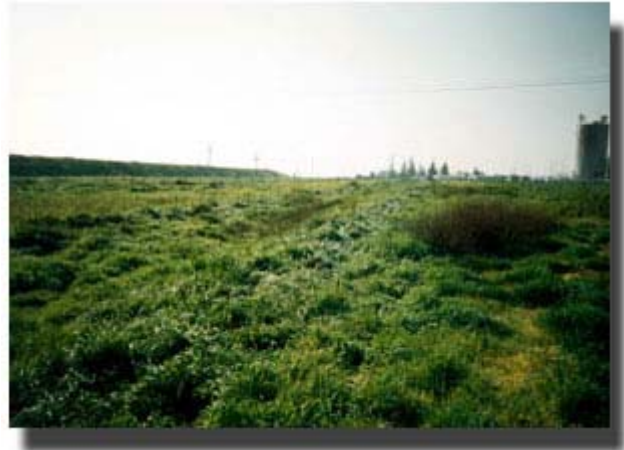
Initial Total Petroleum Hydrocarbon Concentrations in the soil averaged 4,000 ppm. The target for cleanup was 100 ppm which was achieved in 11 months. The soil is covered with native plant life and could be safely used for growing edible crops.

Some native plant life begins to inhabit the site as the contaminant is degraded.
